Acurex Environmental Final Report FR-94-123

ALTERNATIVE-FUELED TRUCK DEMONSTRATION NATURAL GAS PROGRAM: CATERPILLAR G3406LE DEVELOPMENT AND DEMONSTRATION

January 31, 1995

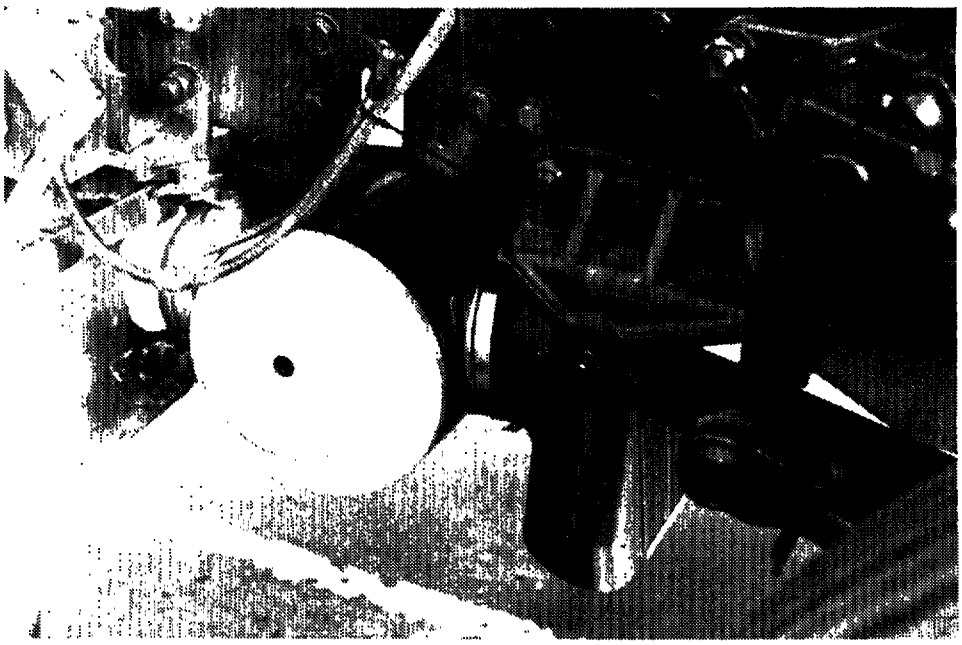
Figure 3-7. Interim air filter

Date	Significant Event
October 12, 1992	Inaugural trip to Bakersfield, California
December 3, 1992	CNG tractor "grounded" because of incompatibility of interim air filter with wet weather; redesigned air filter not yet received from Ford
January 7, 1993	New min-max governor strategy implemented with good results
January 23, 1993	Installation of all-weather air filter completed
January 25-July 22, 1993	Fuel metering at Sun Valley CNG station unavailable because of meter failure
March 15, 1993	First report of engine misfire
April 13, 1993	Press events in Burbank and Bakersfield
April 19-30, 1993	Installation of dual-exhaust system
June 8, 1993	Cause of misfire traced to spark plug gap
June 14-18, 1993	Replacement of primary regulator because of contamination
June 25, 1993	Overhaul of fuel solenoid valve because of contamination
July 8, 1993	Performance test of CNG tractor
July 20, 1993	Hill-climb test of CNG tractor

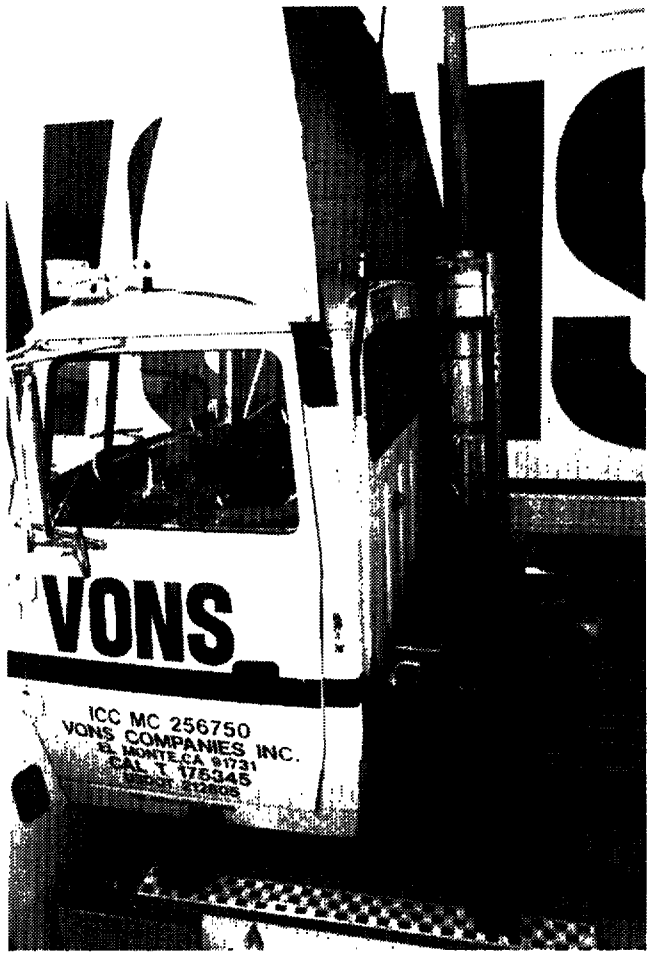
Figure 3-11. Heat insulation

During the first month of the field evaluation, Vons discovered that the CNG tractor's exhaust heat was higher than that of a diesel engine and had caused the deterioration of wires near the turbocharger and of the rubber seal around the rear cab window near the muffler. To remedy this situation, Vons replaced the affected items, installed a shield with insulation around the turbocharger, and added insulation to the muffler; this insulation is shown in Figure 3-11. No further heat deterioration occurred in these areas.

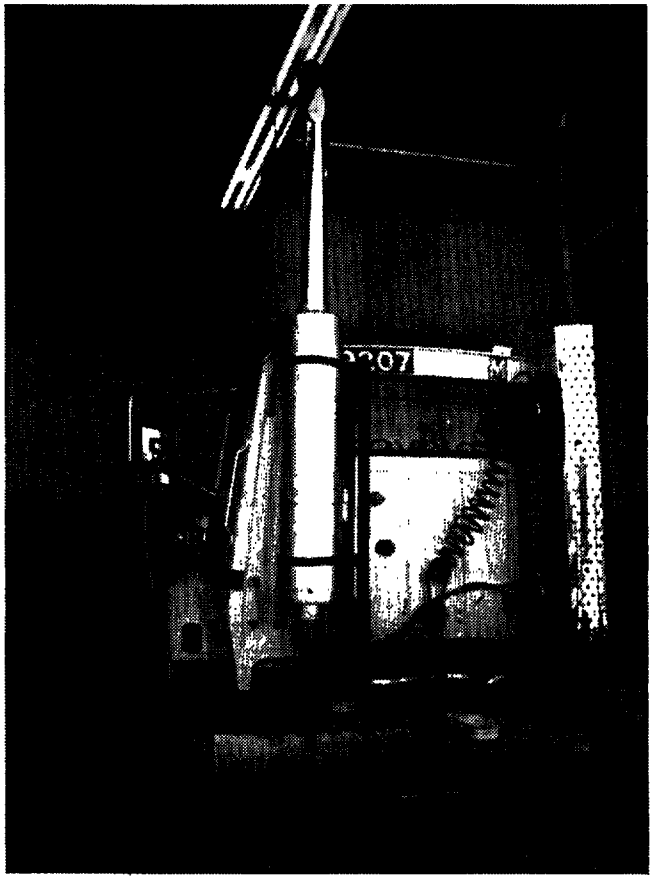
Figure 3-12. Dual exhaust

From the initial tests of the CNG engine following its installation in the vehicle, it was known that the single catalyst/muffler exhaust system was too restrictive for the engine. At 6 months into the demonstration, a second catalyst/muffler unit was supplied by Caterpillar. The installation of the dual exhaust system, shown in Figure 3-12, was engineered by Acurex Environmental, and performed by Power Systems. Location of the second catalyst/muffler unit on the left side of the tractor, opposite the original single exhaust stack, required relocation and replumbing of much of the CNG fuel system, including the fuel receptacle, pressure regulator, and pressure gauges. The original gas panel is shown in Figure 3-13, and the redesigned panel in Figure 3-14. The routing of the exhaust pipe to the original catalyst/muffler was retained; however, a "Y" joint was substituted for the elbow just above the point where the pipe passes vertically between the right frame rail and the transmission. The second branch of the exhaust system begins at this point, with a horizontal tube crossing over to the left side of the chassis. The second catalyst/muffler and exhaust stack is installed in a configuration that is an exact mirror image of the original catalyst/muffler and stack. An identical custom support structure for the left side exhaust was specified, fabricated, and installed. A horizontal tie bar was added, joining the tops of the twin supports for added stability. Figure 3-12 shows the completed dual-exhaust system.

When this work was completed, the vehicle was tested on the dynamometer at Power Systems to measure full-load exhaust backpressure. Earlier tests with the single exhaust indicated that the exhaust backpressure was 14 kPa (56 in H_2O), twice the Caterpillar-specified maximum of 7 kPa (28 in H_2O). Testing with the dual-exhaust system installed showed a full-load exhaust

backpressure of only 3.5 kPa (14 in H_2O), half the 7 kPa (28 in H_2O) maximum. This result enabled Caterpillar to reprogram the spark timing back to the optimal setting established during their development of the engine. Operational data from the field evaluation showed an increase in fuel economy following installation of the dual exhaust. However, because the dual exhaust was installed during a period when accurate fuel metering was unavailable, and because other changes, such as engine returning, were also made during this period, it is impossible to quantify the effects of the dual exhaust alone on fuel economy.

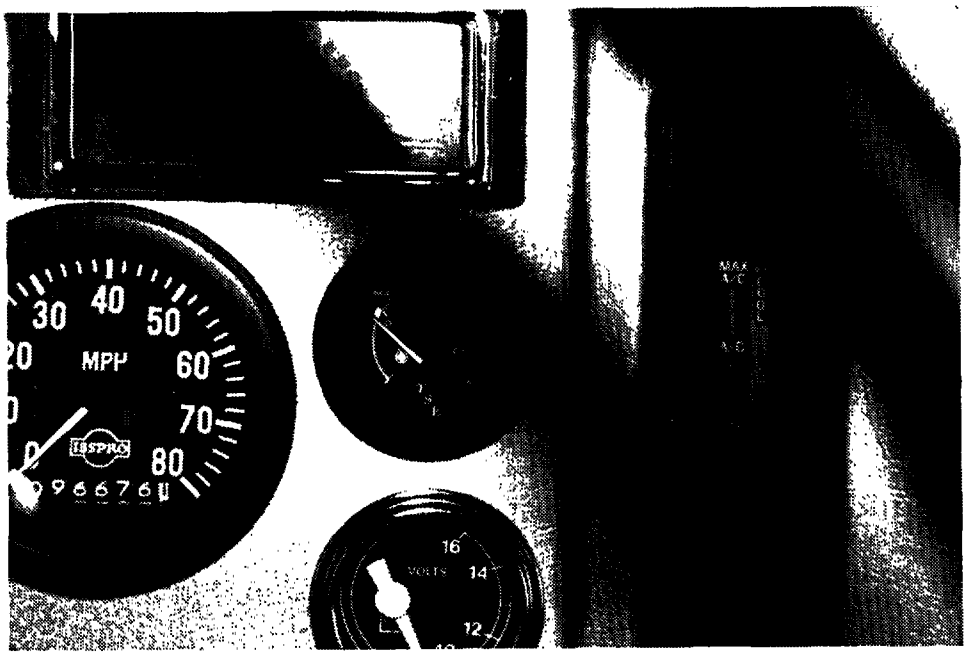
Figure 3-15. Fuel pressure indicator

During the vehicle conversion, a device to drive the standard dash-mounted fuel gauge as a CNG pressure indicator was tested, but could not be made to work properly. Working with the manufacturer of the original device, Acurex Environmental suggested another approach, which proved successful, and which resulted in the manufacturer releasing a new product — a remote pressure indicator matched to the transducer output, which mounts in place of the stock fuel gauge. Acurex Environmental obtained this pressure receiver, shown in Figure 3-15, and successfully installed it in the vehicle in July 1993.

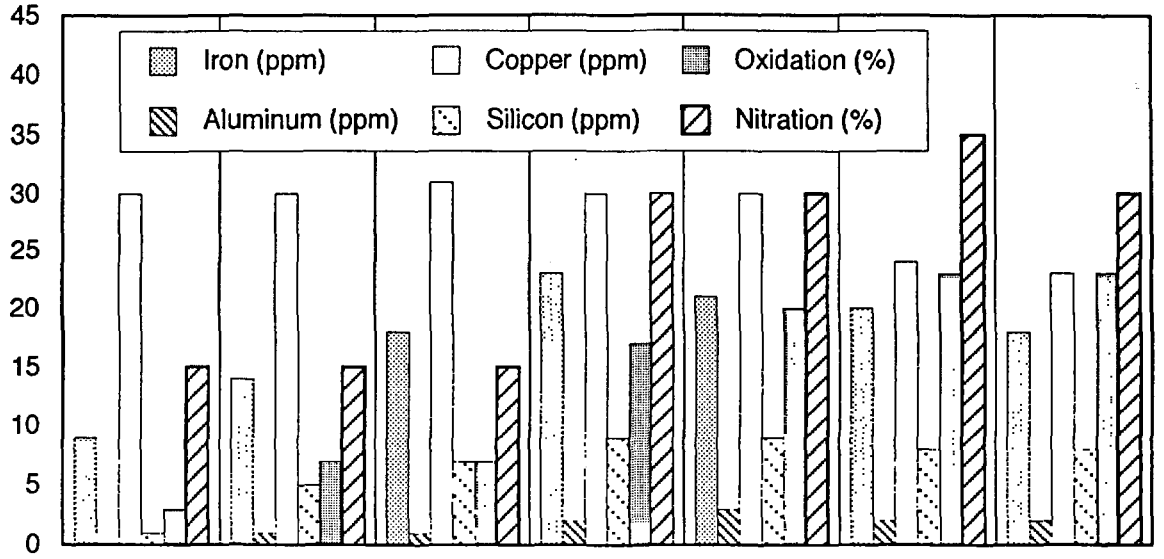
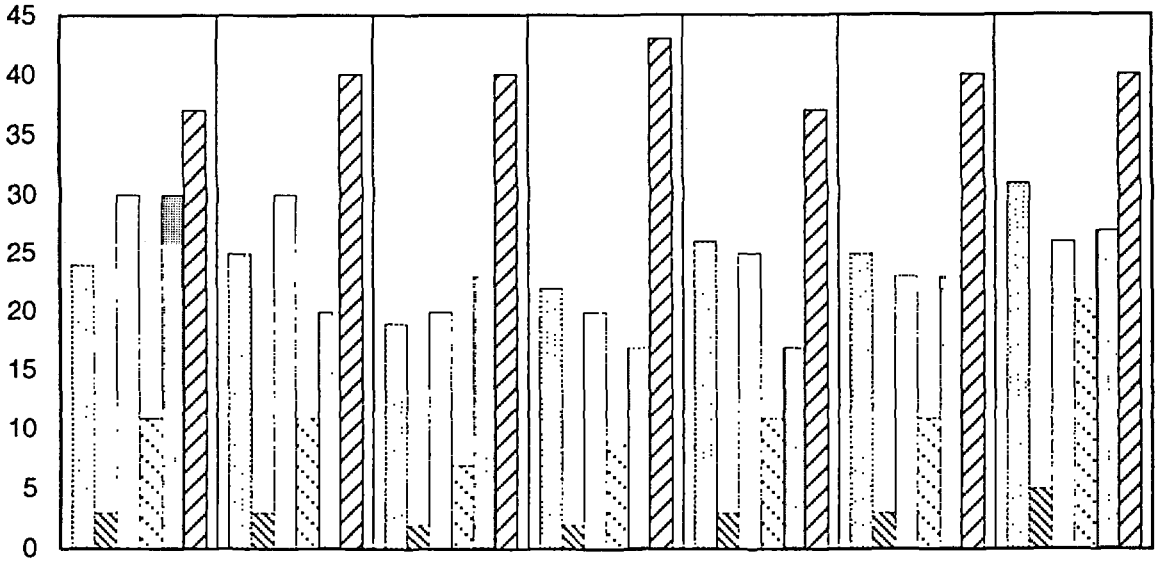
Figure 4-7. CNG tractor oil analysis history

of crankcase oil when the engine was hot, at operating intervals of approximately 50 hours; by measuring oil properties and contaminant levels; and by determining oxidation and nitration levels for each sample. Caterpillar requested the oxidation and nitration analyses to establish an oil drain interval for this engine. The crankcase oil showed no significant deterioration in more than 800 hours of operation, and was not drained during the course of the field evaluation. The oil analysis history of the CNG tractor is plotted in Figure 4-7. The high water content shown in an early sample was attributed to the sample being drawn when the engine was cold.

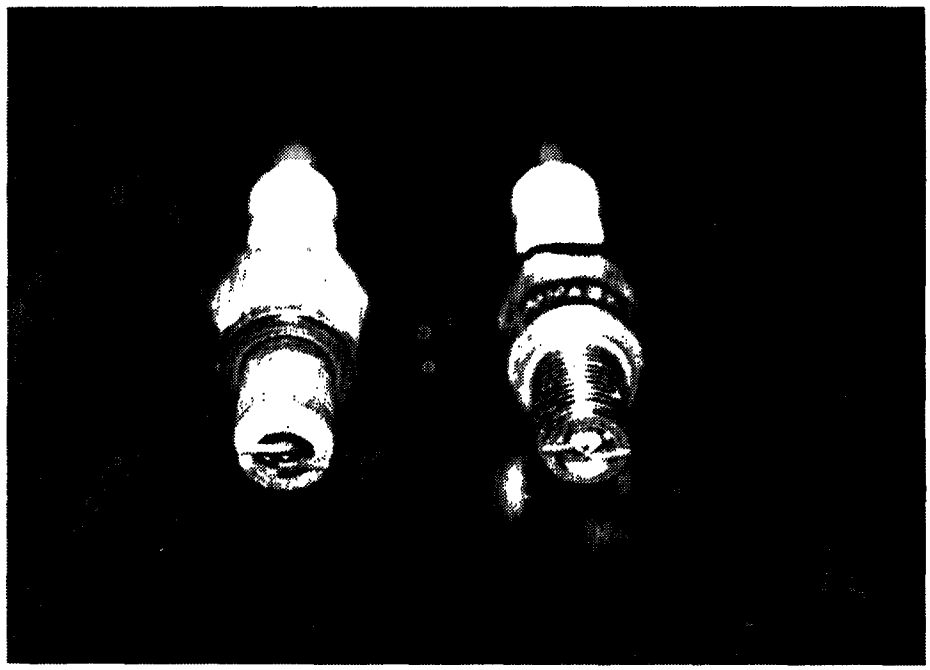
Figure 4-8. Old and new dual-ground strap spark plugs

Engine misfiring was first reported by the driver on March 15, 1993. This was investigated immediately, but was not verified through dynamometer testing until after the dual-exhaust system was installed in April 1993. Initial efforts to diagnose and eliminate the misfire began with the verification of the A/F ratio, and proceeded on to the testing and replacement of much of the ignition hardware, including the spark plugs, the spark plug extenders, the transformers, and the magneto. An old and a new spark plug are shown in Figure 4-8. Success was finally achieved when it was realized that spark plug gaps were spreading in use, at a much greater rate than Caterpillar had anticipated based upon its experience with stationary natural gas engines. From measurements of spark plug gap and occurrences of misfire under load, it was determined that misfiring was entirely absent with spark plugs newly gapped to the 0.38-mm (0.015-in) specification, but would occur under load if the spark plug gaps were 0.4 mm (0.016 in) or greater. Spreading of spark plug

gaps from 0.38 to 0.4 mm (0.015 to 0.016 in) was observed to occur about every 100 hours of engine operation. In response to the spark plug gap spreading problem, Acurex Environmental reset the spark plug gaps to 0.34 mm (0.0135 in) — 0.038 mm (0.0015 in) smaller than Caterpillar's recommendation — to allow for some spreading and to extend the interval for spark plug regapping. Subsequent measurements revealed that spark plug gaps had spread to about 0.38 mm (0.015 in) over the next 200 hours of engine operation. Misfiring did not recur in this period; however, accumulation of engine hours did not continue, so what additional spark plug gap spreading will occur after 200 more hours of operation is unknown.

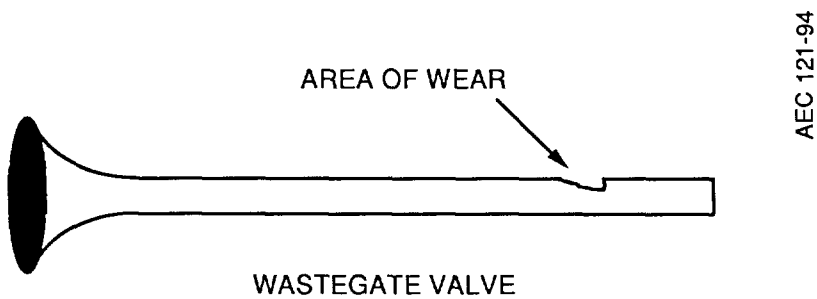
Figure 4-14. Wear on wastegate valve

In October 1993, during dynamometer testing of the truck following repair of an exhaust leak at Power Systems, excessively high horsepower and severe detonation were observed, which led to the discovery of a problem with the turbocharger wastegate. An attempt was underway to adjust the A/F ratio to the correct value when these observations were made. As the A/F ratio was being adjusted, the horsepower increased beyond the rated value, and it was later speculated that the inlet manifold pressure was significantly higher than the desired wastegate setpoint of

103 kPa (15 psi). Power Systems later determined that the turbocharger wastegate valve was stuck in the closed position, causing the engine to operate on uncontrolled boost pressure. Upon the wastegate's disassembly, the wastegate valve stem was found to have excessive wear on one side, possibly causing it to stick. Figure 4-14 is an illustration of the worn valve.
